**MIANUS RESERVOIR DAM
CT 00050**

**PHASE I INSPECTION REPORT
NATIONAL DAM INSPECTION PROGRAM**

DEPARTMENT OF THE ARMY
NEW ENGLAND DIVISION, CORPS OF ENGINEERS
WALTHAM, MASS. 02154

SEPTEMBER 1978

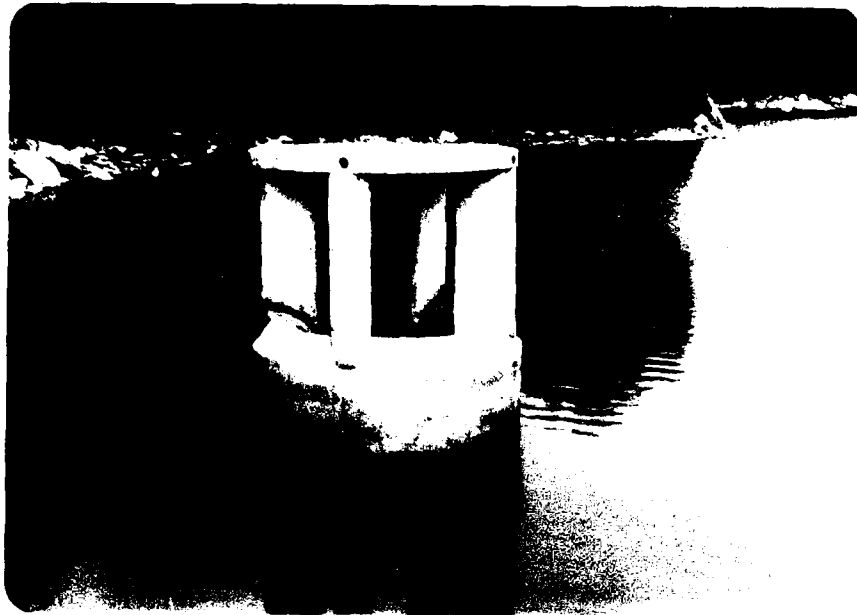
1) Inlet Spillway - The exterior was in excellent condition. The interior was in generally good condition with some spalling noted near the bottom. The base of the drop structure according to the plans is founded directly on bed-rock. The inspection of this feature indicated that an irregular scour hole approximately 5 feet deep has developed. Water is apparently flowing from this area into the outlet pipe at a steady rate.

PHOTO #9: Service spillway - Top of the drop inlet shaft.

3) Subsequent to studying feasible methods, the scour hole at the spillway should be repaired.

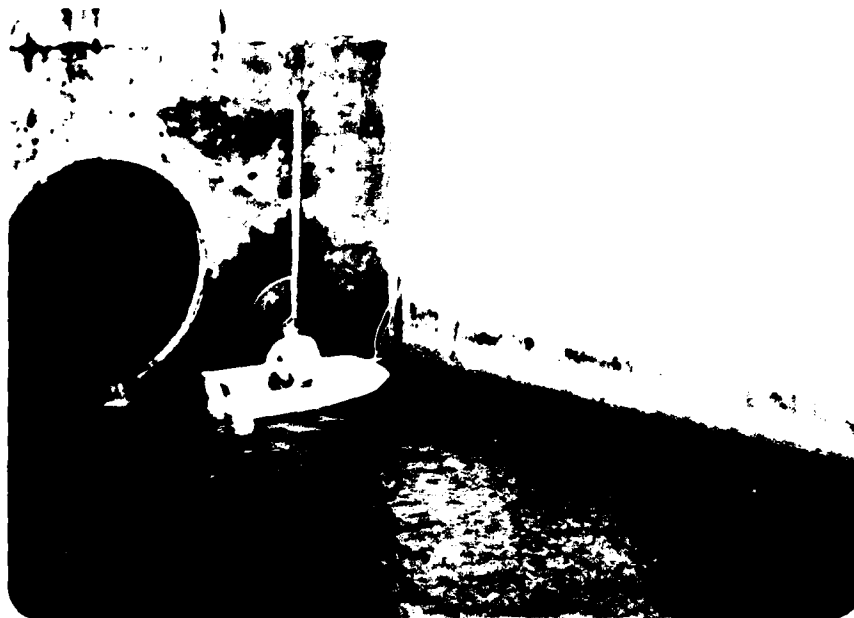
3) Stilling Basin - The concrete endwall and wing-walls are in excellent condition. The bottom of the apron was not clearly visible due to the depth of water. The contacts between the embankment and the outlet structures were in good condition.

4) Blow-Off - The valve for the 30-inch blow-off pipe was easily opened by one man. The flow from the blow-off was clear and free of debris. Upon closing the valve, there was no leakage observed. The end of the blow-off pipe was in good condition.

PHOTO #11: Outlet of the service spillway discharge conduit,
and adjacent blow off.

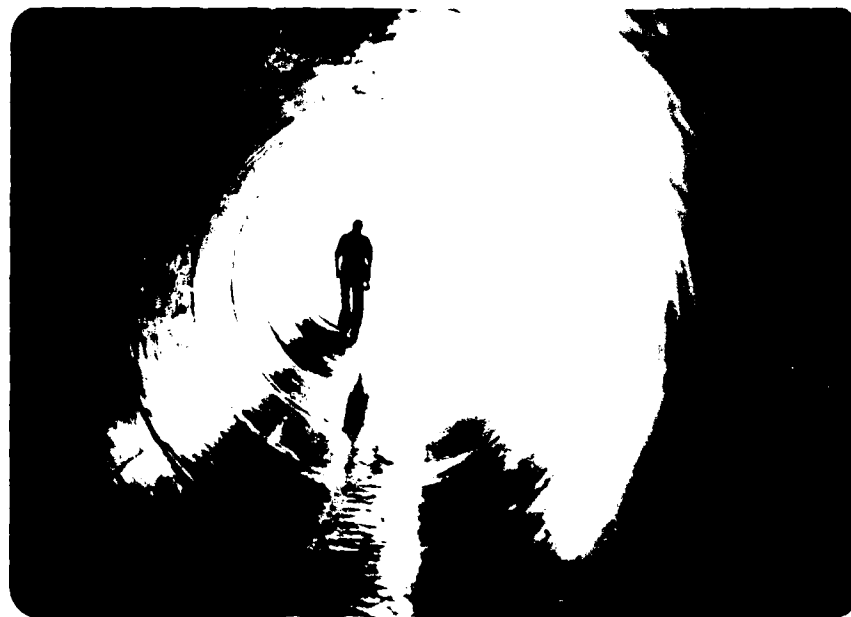
2) Spillway Conduit - The interior of this 8 foot diameter conduit was inspected and found to be in generally good condition. Some hairline cracking was noted at the crown, with efflorescence and moisture also observed. The two sections of pipe nearest the inlet structure were found to have little or no mortar at the joints. No indication of spalling or deterioration of the concrete surfaces were noted. Alignment of the joints was good, there is an apparent slight sag in the pipe profile, about where the pipe passes beneath the dam crest.

PHOTO #12: Interior view of the service spillway discharge
conduit.
